# Observed rock mass degradation and resulting slope instability

**ABSTRACT:** After excavation of a road cut, weathering and erosion processes will start acting upon the newly exposed slope material. Field observations show that the resulting degradation caused by stress release, weathering and erosion may have significant effects well before the envisaged end of the engineering lifetime of the road cut. Since 1990 a road cut in Upper Muschelkalk limestone was monitored to study these effects. The classifications and laboratory test results show that degradation of the rock material and rock mass has progressively continued throughout this period, and threatens the stability of the current slope by causing a notable decrease of the bedding plane's friction angle. The test results also show the limited usefulness of shear box testing for slope stability assessment. The small size of shear box samples can lead to both a serious over- and underestimate of the in-situ shear resistance.

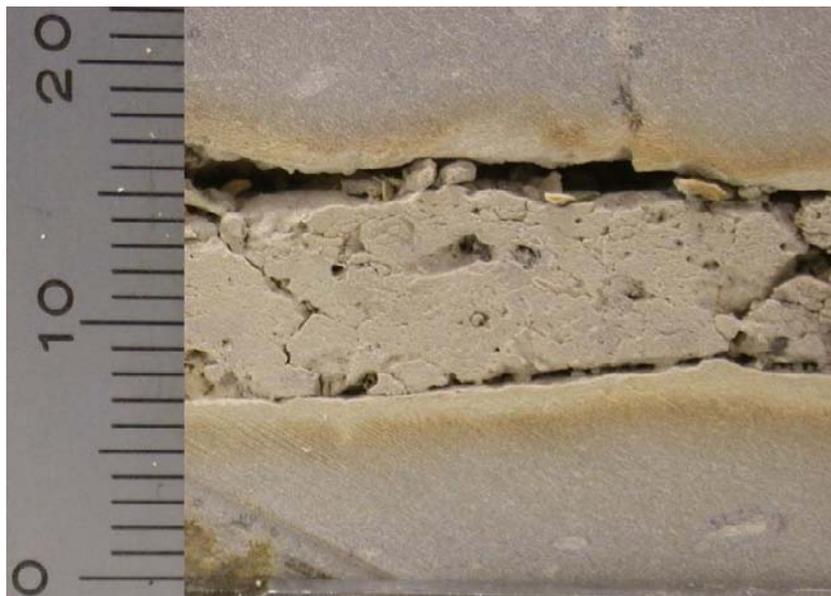
In 1991, the bedding planes were found to contain some clay infill (Cindarto, 1992). This was at the time no more than a thin dusting on the bedding plane surface, and thought to result from weathering as the bedding planes often contain some minor contents of clay. In 2002 parts of the outcropping bedding planes, and especially the bedding plane which acted as sliding plane in 1991, were found to contain a significantly thicker slightly plastic layer of approximately 8mm (see Figure 1).

**Figure 1 - The plastic layer developed on the bedding plane in cross-section (shear box sample, 2003; scale in mm)**

Material analysis using XRF/XRD testing indicated a montmorillonite content in this layer of approximately 3% by volume, which explains the plastic behaviour. Furthermore, the presence of even such small amounts of montmorillonite suggests that the layer is vulnerable to further weathering and weakening (Kühnel, 2002). The total clay content including non-swelling clays is approximately 14%. Apart from the plastic layer, the discontinuity walls were weathered to a depth of about 1mm (see Figure 1). Block samples incorporating this plastic layer were taken for shear box testing in 2003, to compare with the results of the 1991 tests.
