Fieldwork campaign in Ruqigou coalfield, China

This project entitled 'Development and implementation of a coalfire monitoring and fighting system in China' is a collaborative project between the BRSC (Beijing Remote Sensing Corporation) and a Dutch consortium, which consists of EARS (a private company), RGD (Geological Survey of the Netherlands) and ITC. It is sponsored by the Chinese and the Dutch Government. This three year project started in July 1996 and aims at setting a prototype GIS for coalfire management. Information from remote sensing images, geological studies, geochemical studies and other field studies form the basic inputs in this GIS.

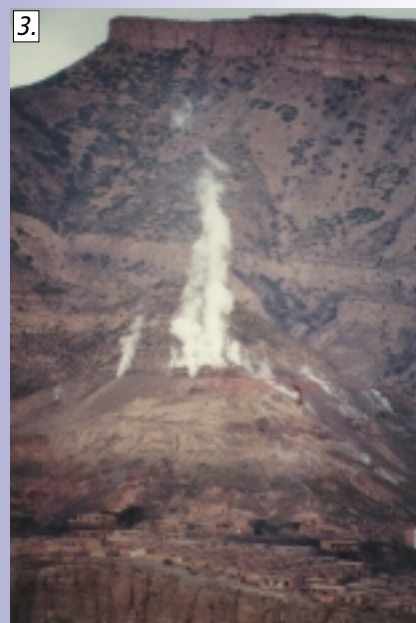
Photo 2:
Cracks occur as a result of land subsidence where underground fires diminish the thick coal layers.

Most interesting phenomena were captured by the cameras. Massive crack structures, smoke and steam emitting vents, blazing coalfires, opencast and underground mining sites and areas with high pollution levels were among the most striking features observed in the field (photo 2,3,4,5).

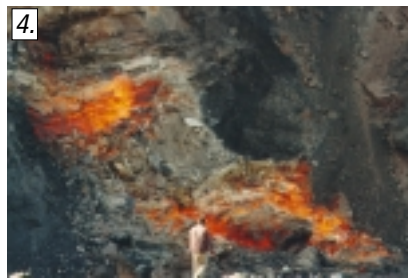
Photo 3:
Smoke and steam show where the coal is burning. Steam usually occurs where water is injected for fire fighting.

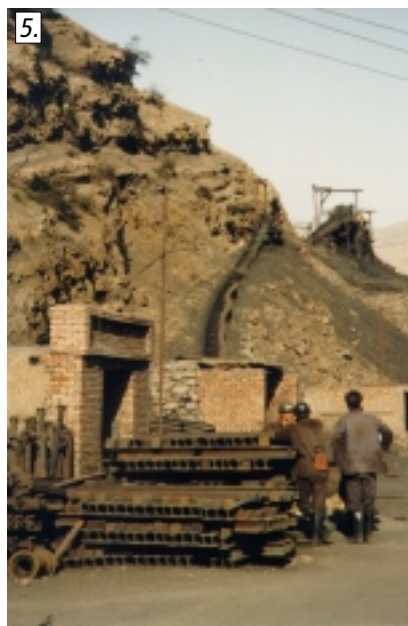
Photo 4:
Coalfires damage coal reserves, risk human lives, pollute the environment and create obstacles for mining.

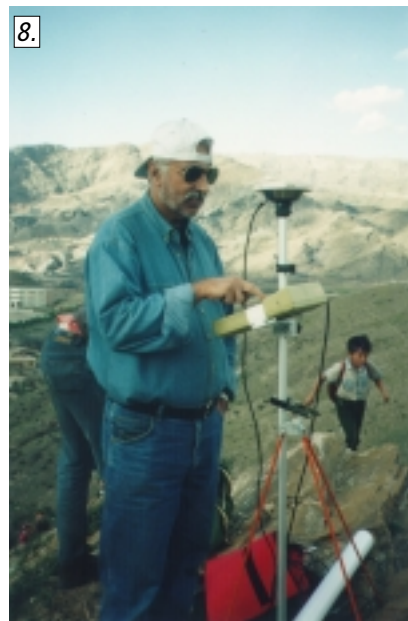
Photo 8:
GPS was used to locate the measurement spots.

● GPS measurements: High precision GPS were used to measure several locations in the field. Parameter of transformation were computed to transform the GPS coordinates to the local coordinate system (photo 8).

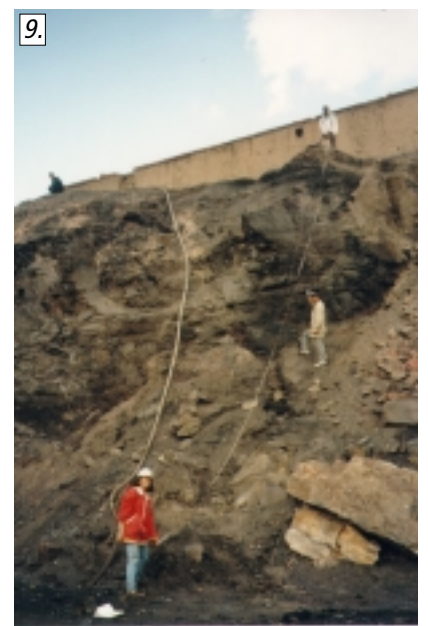
Photo 9:
Detailed geological measurements, samplings and observations were carried out.

● Geological sampling: Several coal samples were collected from different coal seams. The sampling was done to cover the entire study area (photo 9).
