Post-earthquake Damage Assessment Using Satellite and Aerial Video Imagery

Post-earthquake damage assessment using satellite and aerial video imagery

Thesis submitted to the International Institute for Geo-information Science and Earth Observation in partial fulfilment of the requirements for the degree of **Master of Science in Urban Planning and Land Administration**.

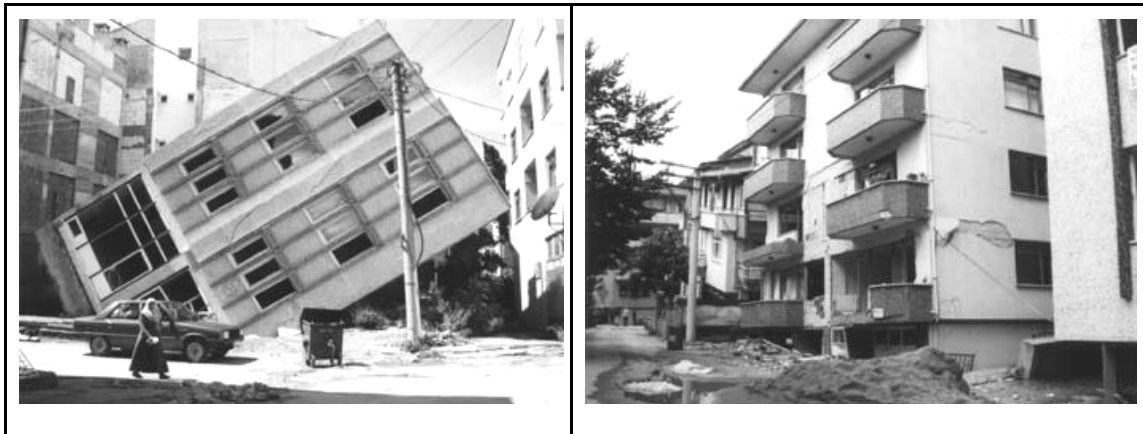
1. *Foundation failure* was resulted with the severe settlement of the buildings or overturned structures mostly seen in Adapazari. Soil liquefaction or bearing pressure failures were the main reason for the foundation failure (Bruneau, 2002).

Figure 3.8. Damage due to foundation failure
(AIJ, 2000)

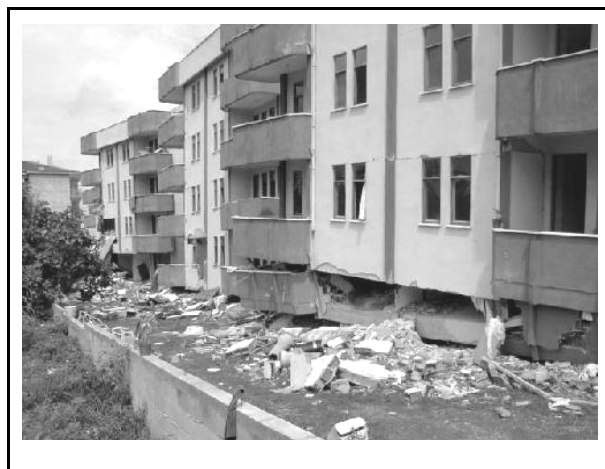
2. *Existence of soft story*, which is a floor that is structurally significantly more flexible and weaker than the others, increases the demand for deformation and puts the entire burden of energy on the soft stories. Commercial use of the first or lower floors, which were entirely or partially, enclosed by glass was major reason for soft story collapses (Bibbee *et al.*, 2000; Bruneau, 2002).

Figure 3.9. Damage due to soft first storey
(<http://mceer.buffalo.edu> visited on 14 November 2003)

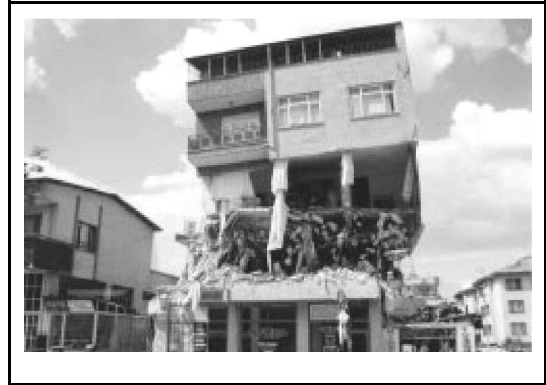
- a. Damage to buildings with soft first story (Yoshimura *et al.*, 2003). It was the most common collapse.
- b. Damage to buildings with soft lower stories (Yoshimura, *et al.*, 2003).
- c. Damage to buildings with soft intermediate stories (Yoshimura *et al.*, 2003).

Figure 3.10. Total collapse of intermediate storey
(Yoshimura, *et al.*, 2003)

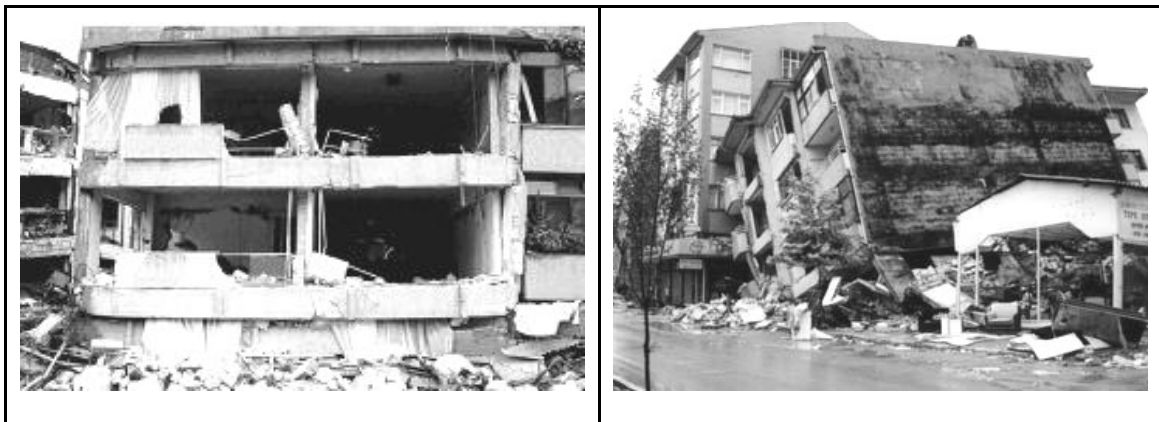
- 3. Strong beams and weak columns resulted in failure in the form of compression crushing, plastic hinging, or shear failure (Bruneau, 2002).

Figure 3.11. Strong beams weak columns
(Bruneau, 2002)

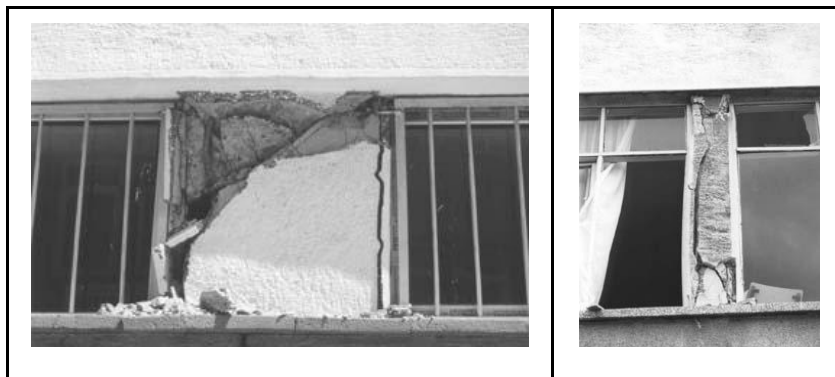
- 4. Lack of column confinement and poor detailing practice resulted in damage on the column ends (Bruneau, 2002)

Figure 3.12. Shear failure in short captive columns ‘trapped’ between partial height infill, and flexural failure in non-ductile reinforced concrete plastic hinges
(Bruneau, 2002)

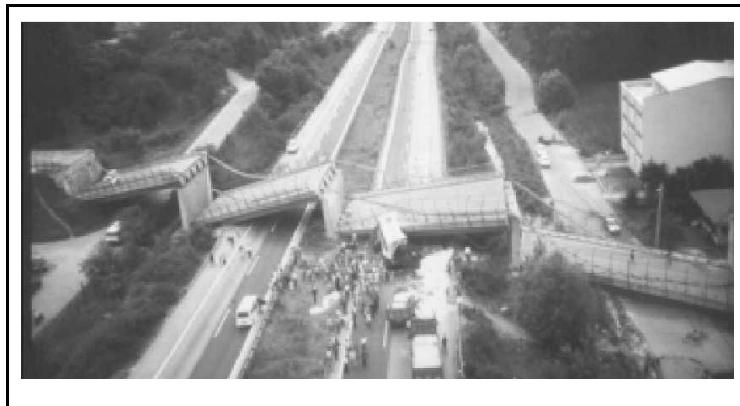
Figure 3.14. Collapse of Arifiye overpass on TEM highway
(Erdik, 2003)

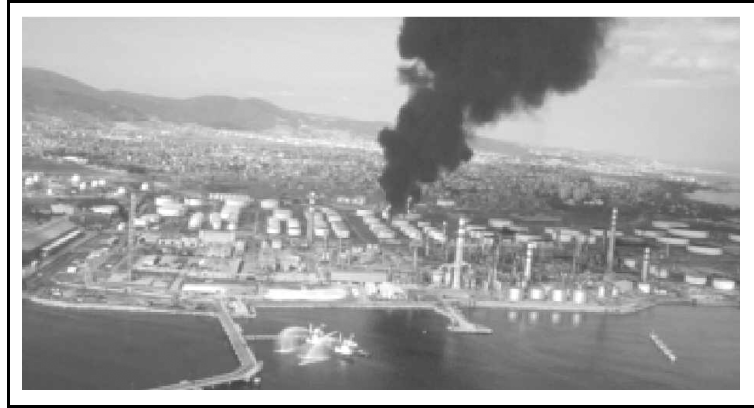
Tupras is one of the largest refineries of Turkey, processing about one third of Turkey's oil. It is the 7th largest refinery in Europe (AIJ, 2000) with a production capacity of 12 million tons per year. Tupras is situated 5 km away from the fault line. Besides significant structural damage to the refinery itself due to earthquake, the consequent fire in the refinery caused extensive additional damage. Six tanks out of 120 tanks in the farm tank were damaged due to ground shaking and fire. The fire continued for three days and created danger for whole region. The economic loss was estimated to be US\$350 million (Erdik, 2003).

Figure 3.15. Fire in Tupras petrochemical complex
(Erdik, 2003)

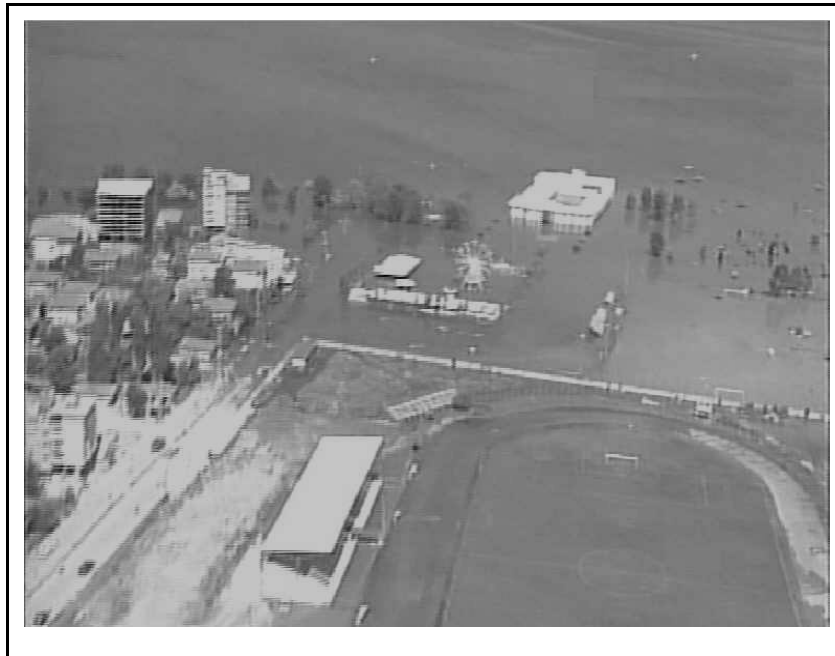
Figure 3.18. Submerged area in Golcuk
(Show TV, 1999)

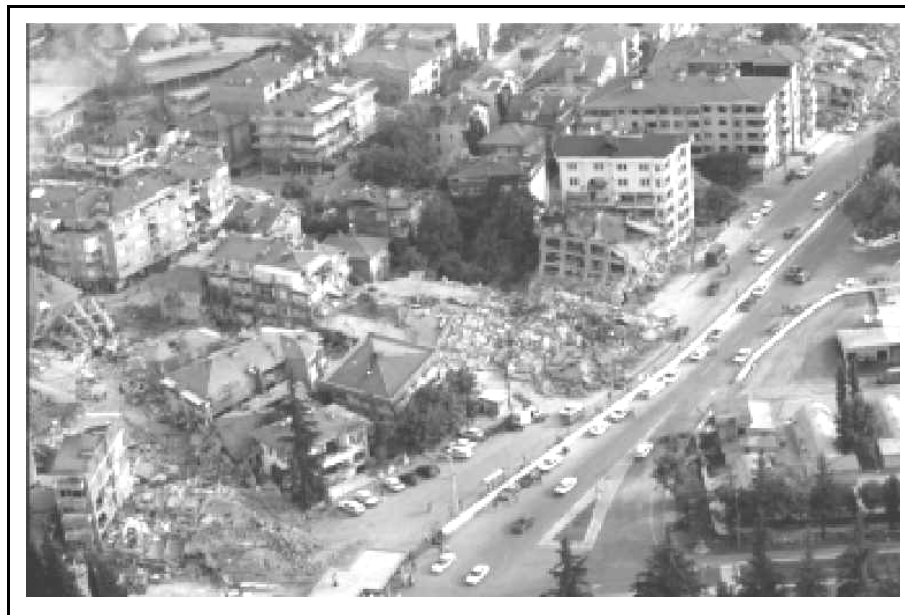
2.350 building were collapsed or heavily damaged. The number of collapsed housing unit was to be estimated around 12.500. 1.816 buildings were moderately, and 2.772 building slightly damaged (Kocaeli Province, 2003). According to the Golcuk municipality, the number of the building in pre-earthquake situation was 6.000. This figure shows that more than 30 percent of the total buildings were collapsed or heavily damaged. The number of total building damages of the Kocaeli province is presented in Appendix 6.

Figure 3.19. A general view of building damage in Golcuk
(Erdik, 2003)

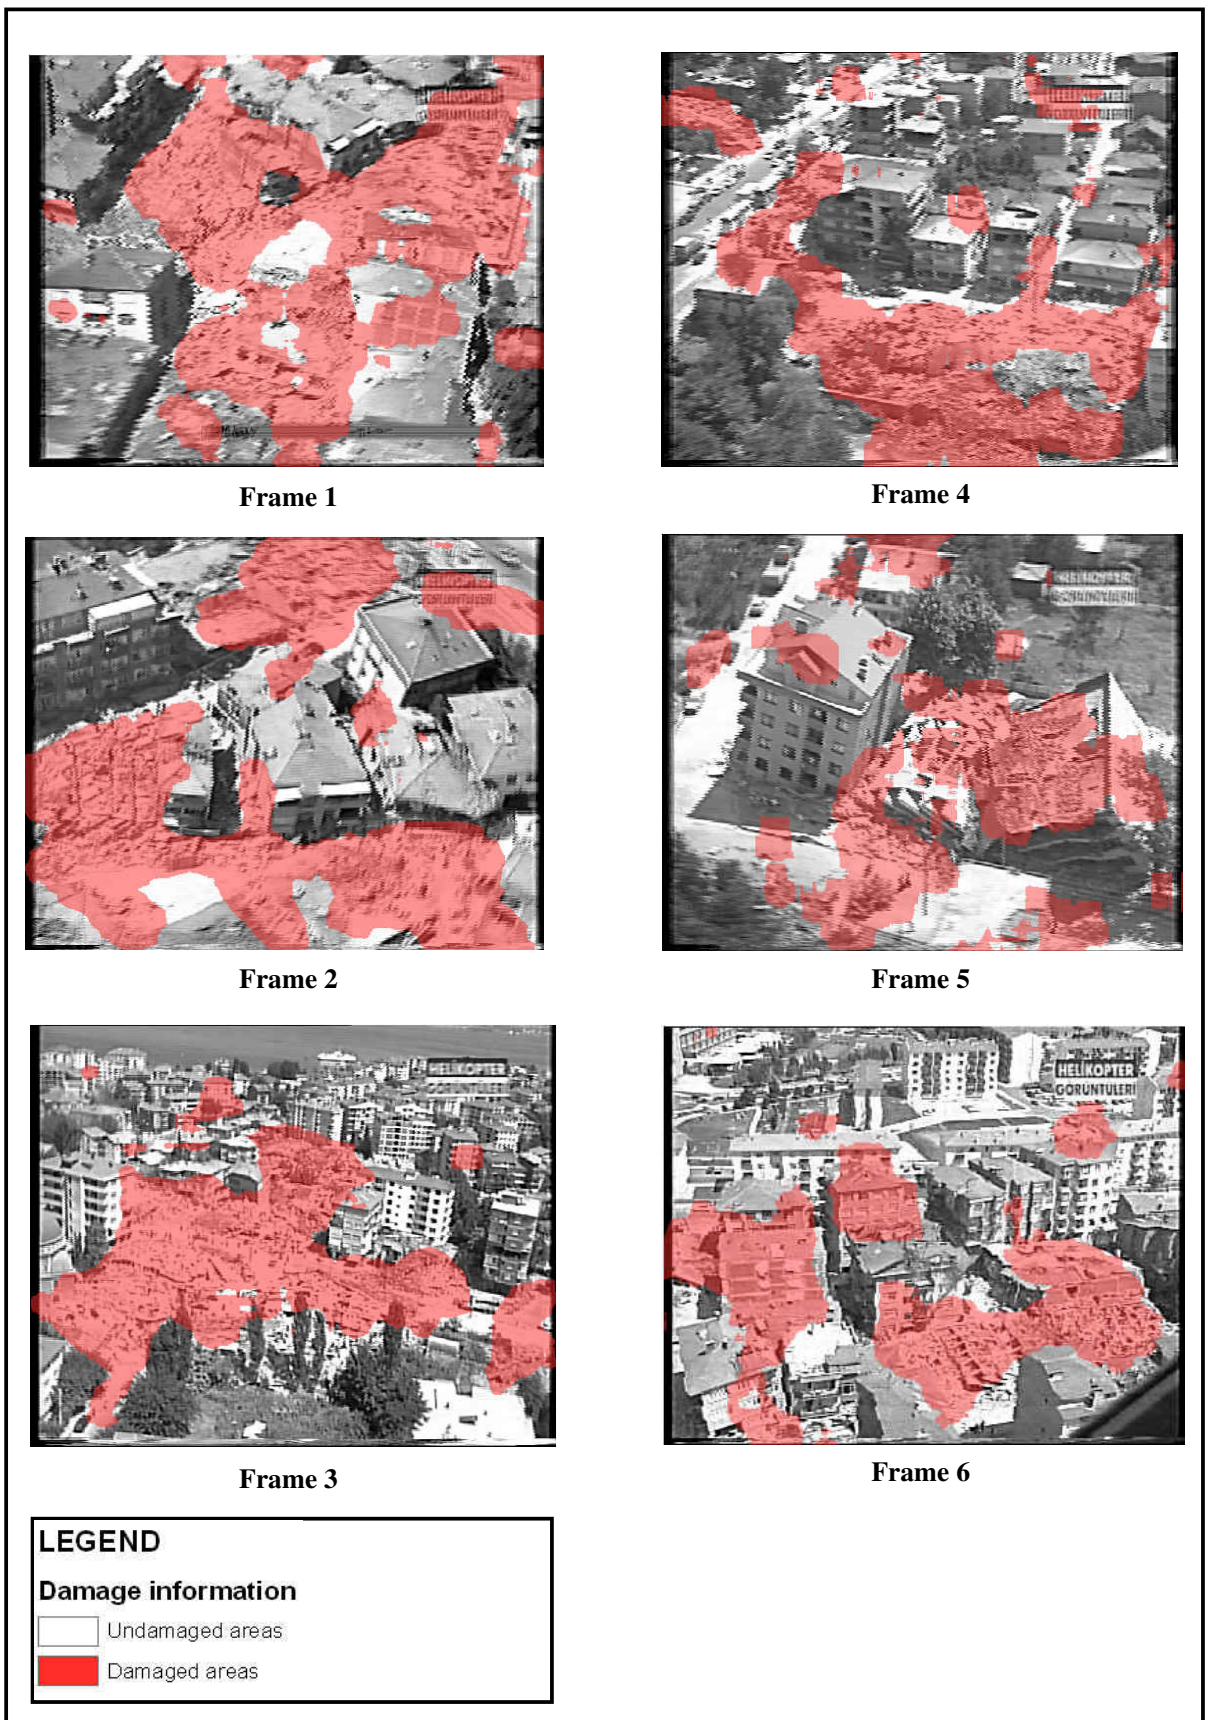
Hue, saturation variance, edge and edge variance layers were used in multi-thresholding process. The same thresholds were applied to other five frames to assess the effectiveness of the methodology. A 61x61 mean texture window was used to aggregate and to remove spurious pixels derived from the multi-thresholding process. The size of the window (61x61) was decided based on the average building size in the video frame. The result of the analysis of video imagery is provided in Figure 7.9.

Figure 7.9. Damaged areas derived from the video imagery

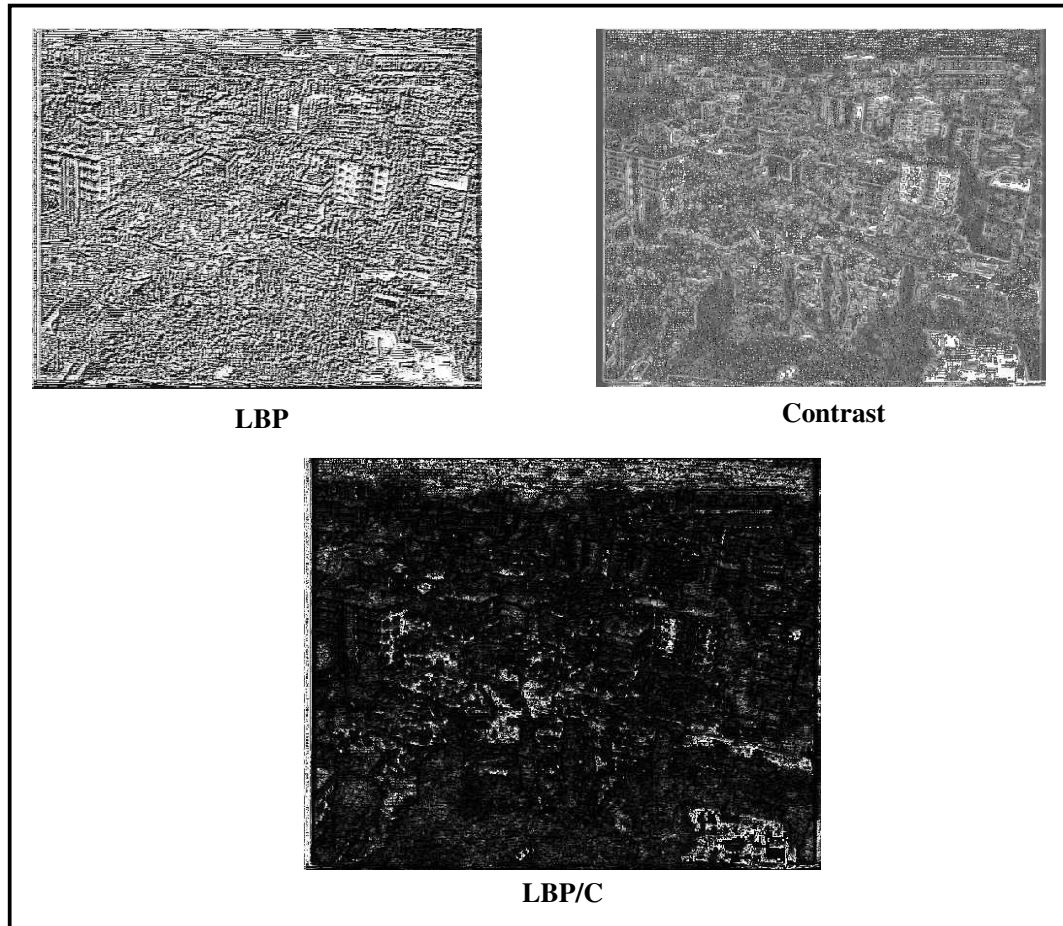
Figure 7.21. Local binary pattern and contrast layers
