**LAND USE CHANGE AND LAND DEGRADATION:
A CASE STUDY IN NAM CHUN SUBWATERSHED IN THAILAND**

KEYWORDS: land use change, land degradation, landslides, soil erosion

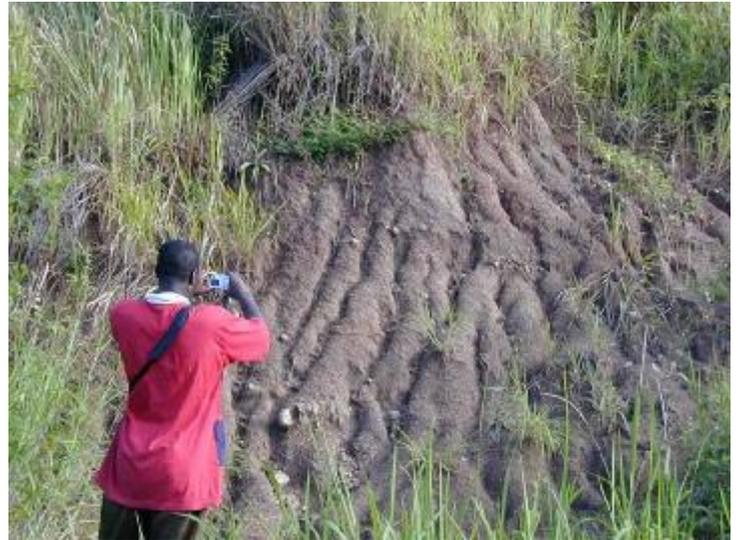
Fig.2: Rill erosion is common on bare surfaces

The study of land use change approved the conclusion drawn from the geopedologic survey that the main cause of land degradation is deforestation. On bare surfaces and on maize cultivation fields rill erosion is common (Fig. 2). Besides, the study reveals that landslide takes place on deforested steep mountain slopes (Fig. 3). Soil loss assessment by applying erosion model (Morgan, 2001) shows that soil loss is highest in areas under annual crops (20 - 40 t/ha/yr) followed by orchards (10 - 20 t/ha/yr) and degraded forest and grazing land (<10 t/ha/yr). Soil loss assessment map is shown in Fig. 4.

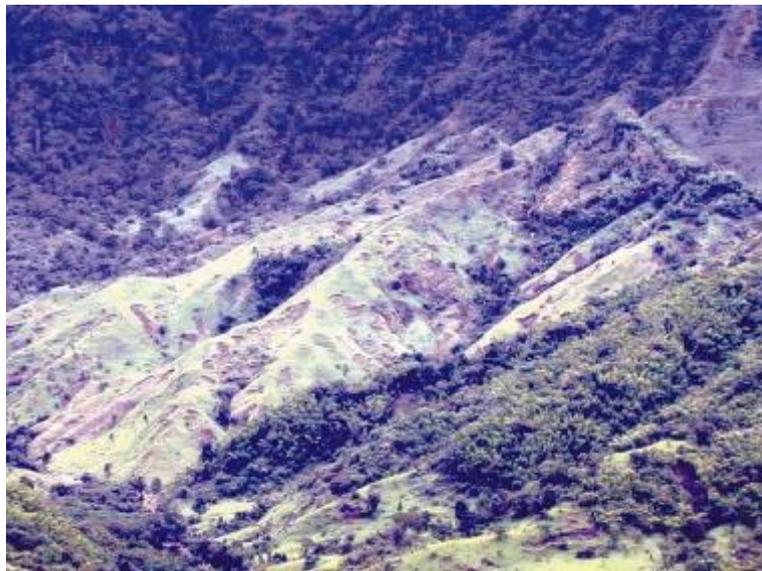
Fig. 3: Landslides are common on deforested steep mountain slopes
